# ARMY GROUND RISK-MANAGEMENT PUBLICATION COUNTERMEASURE

VOL 21 NO 2

FEBRUARY 2000

# Bradley Has New Rollover Procedures

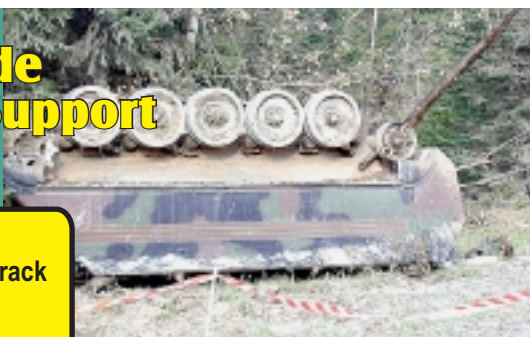
the vehicle to slide off the tank trail onto a soft shoulder, landing on its top.

The accident occurred as the vehicle traveled along a tank trail during normal operations. A track shoe on the right-side track of the vehicle tore apart due to the track pin tearing through the track shoe shore. Inspection of the broken track shoe revealed that the track shoe bushing was worn away, producing metal-on-metal contact. Because of this metal-on-metal contact, a friction-producing movement was applied to the track pin against the track shoe shore, causing the shore to wear down and the track to separate at that location.

The complete separation occurred on the inside portion of the track shore, followed by a fracture failure on the outside portion of the track shore with a noticeable bend in the track pin. In addition, the track shoes on both the right- and left-side track were non-mission capable (NMC) due to worn bushings and bent track pins; thus, the vehicle should have been deadlined. Further, there were three other NMC deficiencies found on this vehicle, but there was no evidence of a pre-mission preventive maintenance checks and services (PMCS) conducted to identify these deficiencies.

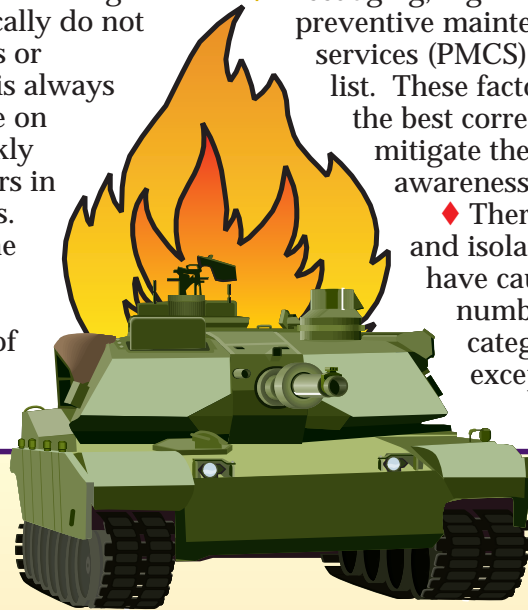
## ABRAMS TANK FIRES DURING CY95 - CY99 BY "CAUSE OF FIRE"

1999	1998	1997	1996	1995
HYDRAULIC FIRES	10	8	6	0	3
NBC FILTER FIRES	9	2	1	6	4
FUEL LEAKS	7	4	5	3	2
ELECTRIC	6	5	1	5	5
TRANSMISSION CROSSOVER TUBE	2	0	1	0	0
OTHERS	5	4	2	7	0
TOTAL FOR YEAR	39	23	16	21	14

♦ The fire causes are strictly random and have been throughout the life of the Abrams tank. There is not one fire category that stands out as the
